Ōtūmoetai Pool - Information Pack

Asset Condition Assessment

OTUMOETAI POOLS CONDITION ASSESSMENT

21 MARCH 2024

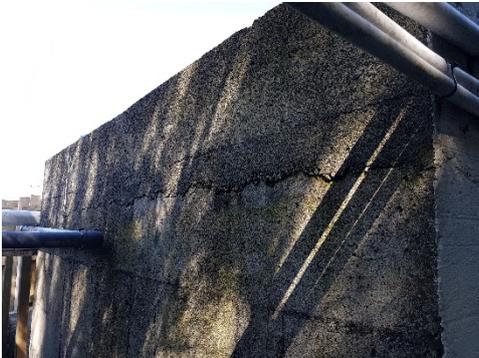
4.5.2 Balance Tank

There appears to be minor water leakage through the construction joint between the tank walls and roof slab. There is no spalling apparent, so reinforcement corrosion is not significant yet. This does pose a long term durability issue however unless it is addressed.

Repair options include epoxy grout injection of the crack or providing an internal membrane to the tank.

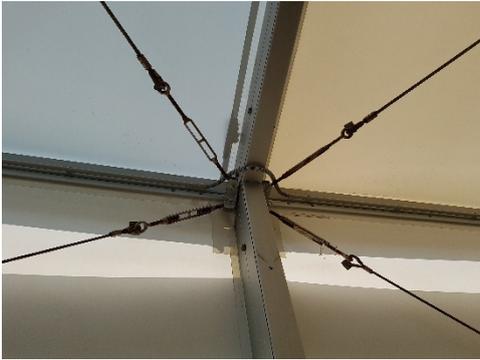
There is minor surface corrosion evident to wire rope bracing cables, ferrules, thimbles, eye bolts, turnbuckles and bolts, most likely due to condensation. While not structurally significant, this is a long term durability issue and these items will require replacement.

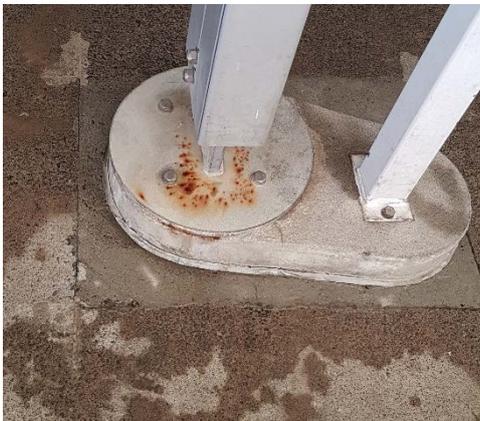
There is minor surface corrosion evident to the roof frame baseplates due to water ponding. While not structurally significant, this is a long term durability issue. It is recommended that the baseplates and bolts are cleaned and corrosion protection reinstated.

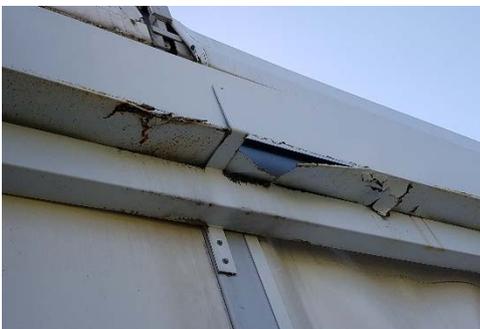
The roof external gutter shows signs of corrosion in a number of places. While most are minor surface corrosion, some exhibit complete failure. As the gutters are thin folded metal, complete replacement is recommended for long term continued use.

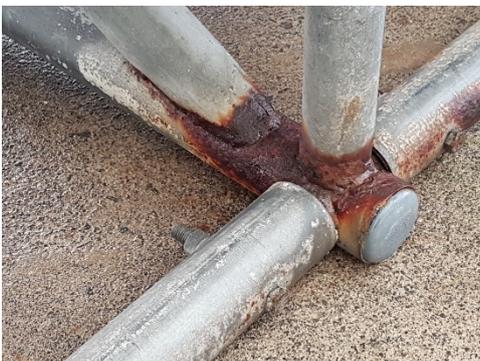
The frame connections at the front of the grandstand all show signs of corrosion, varying from relatively minor to full through thickness failure. The corrosion is limited to the joint locations where original corrosion protection has been affected by welding and either not or insufficiently reinstated. The corrosion is due to the aggressive pool water being splashed onto the frames from the concourse slab. This is a short term durability issue.

It is recommended that the grandstand structure be repaired by removing surface corrosion and reinstating corrosion protection to joints as required. The joints at the front of the frames may require partial replacement where corrosion and loss of material thickness is significant. A higher specification corrosion protection should be considered here (two component epoxy paint) as well as lifting the grandstand slightly to prevent immersion in ponding water.

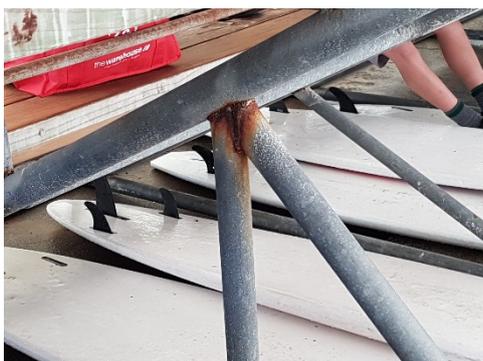
Other frame connections also show signs of corrosion, though not as significant as the front as they are elevated and more distant from the pool and less likely to be splashed. The corrosion is likely to be due to water dripping from swimmers on the grandstand and condensation.

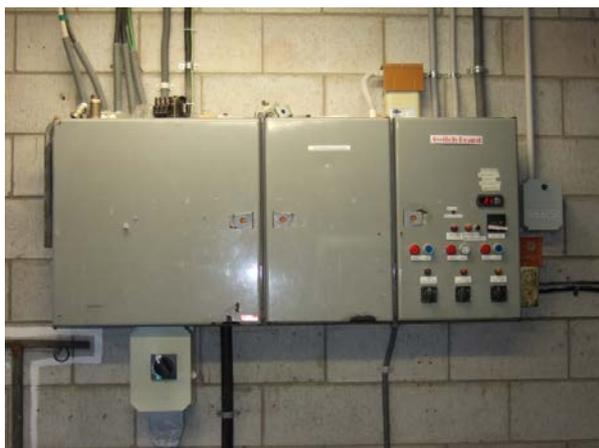
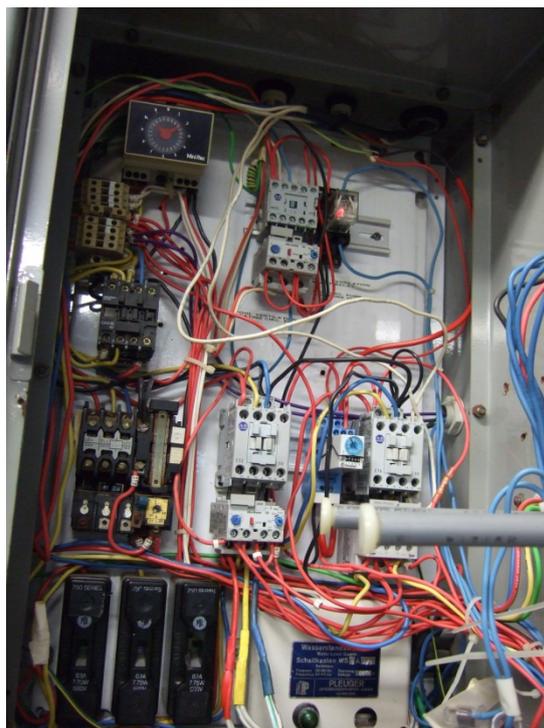
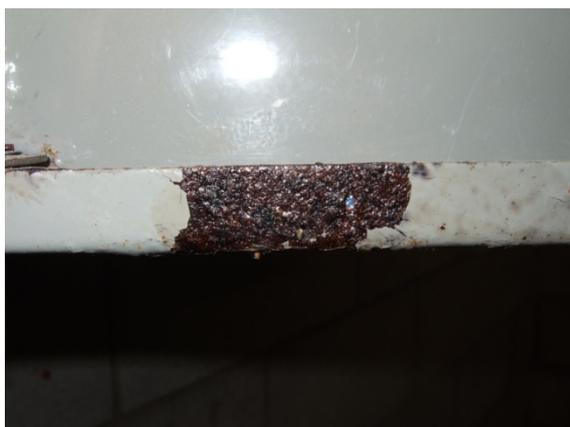
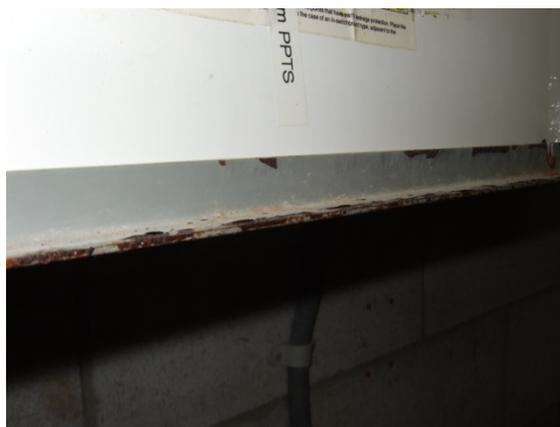
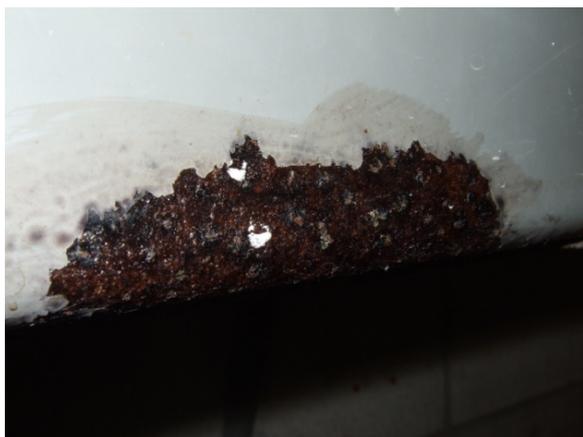
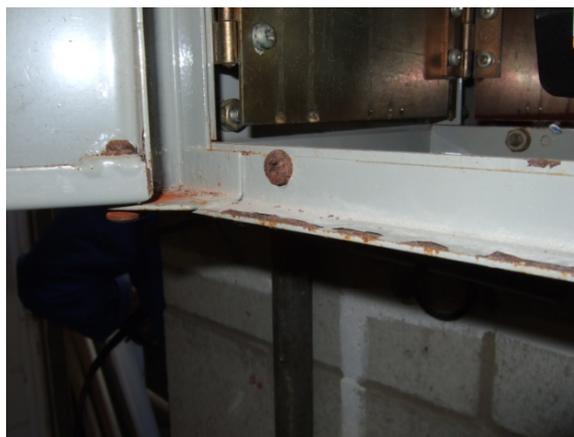
7.1 Main Switch Board

The main switchboard was manufactured by Gael Switchboards Ltd and is made of steel with a painted finish. The board is made up of three cabinets. The cabinet on the left is the meter panel and has new metering in it which can be re-used. The centre cabinet is for distribution and consists mainly of fuses but a new three phase RCD and MCB has been installed for pool cleaner socket outlet. A RCD for the plant room power points also exists but is an older model and would only have a remaining life of approximately 3 years.

The cabinet on the right is a motor control cabinet and consists of direct-on-line starters inside and rotary switches, push buttons and indicator lamps on the panel door. There are contactors and overloads which have a limited life span remaining and will require an upgrade in the next year. The remaining contactors and overloads have a further five year life span.

The main switchboard shows considerable signs of rust due to the environment that it is situated in.

Component	Description	Findings	Recommendation	Photo	Timing	Cost
Main Switchboard	MSB, DB and control panel	Considerable rust on panels, original fuses, old type contactors and overloads, damaged push buttons and indicator lights	Replace complete SWB, DB and control panel		2 years	\$12k

- The main switchboard, located in the plant room, consisting of metering panel, distribution panel and control panel, to be upgraded.
- Main switch and metering equipment to be re-used but fuses in DB replaced with MCB's and control panel replaced with new contactors, controllers, overloads, push buttons, rotary switches and indicator lights.

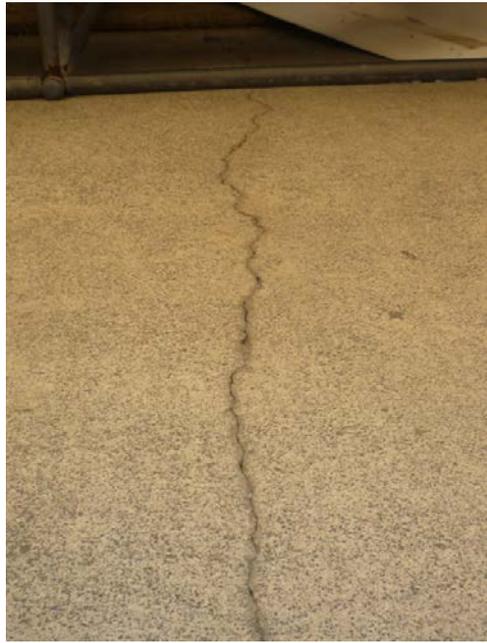
9.1.3.1	Severe Cracking					9.1.3.2 Exposed Reinforcement

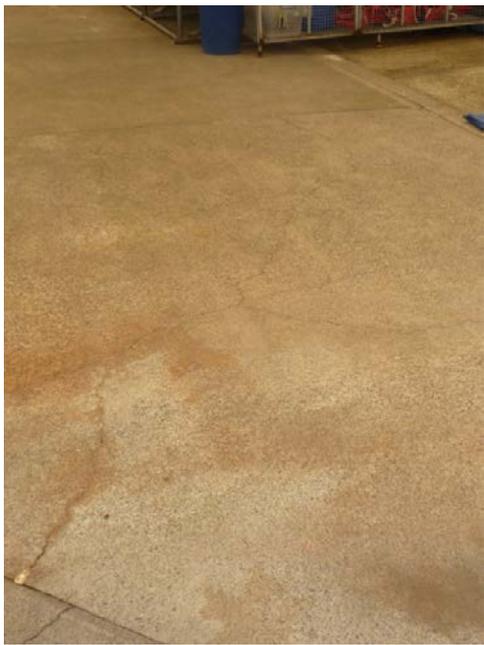
9.1.3.3	Unsealed Joints		9.1.3.4	Broken Concrete Block

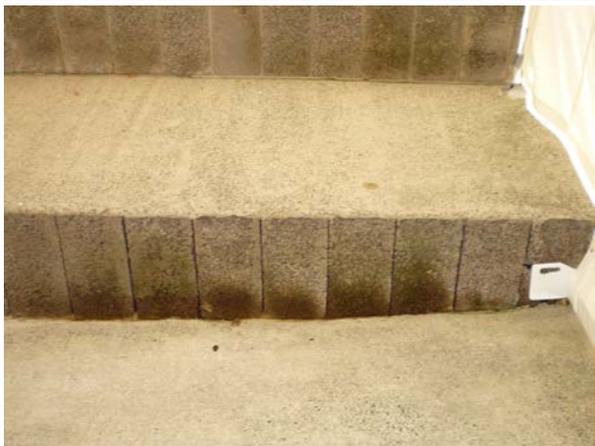
9.1.3.5	Gaps and Crevices

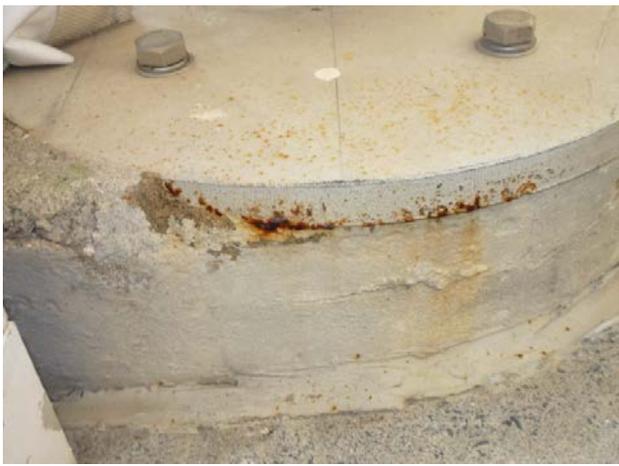
9.1.4.5	Painted Frame Base Plates

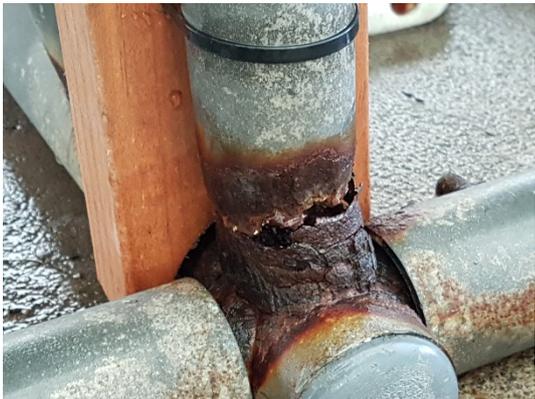
Component	Description	Findings	Recommendation	Photo	Timing	Cost
Seating support frame	Galvanised steel tube triangulated frame.	Significant corrosion to frame joints at front. Surface corrosion to some other joints also.	Locally replace frame members where loss of section significant. Clean and repaint elsewhere	9.1.5.1 9.1.5.2 9.1.5.3	1 year	\$20kto \$25k

9.1.5.1	Full loss of section					
			9.1.5.2	Surface corrosion

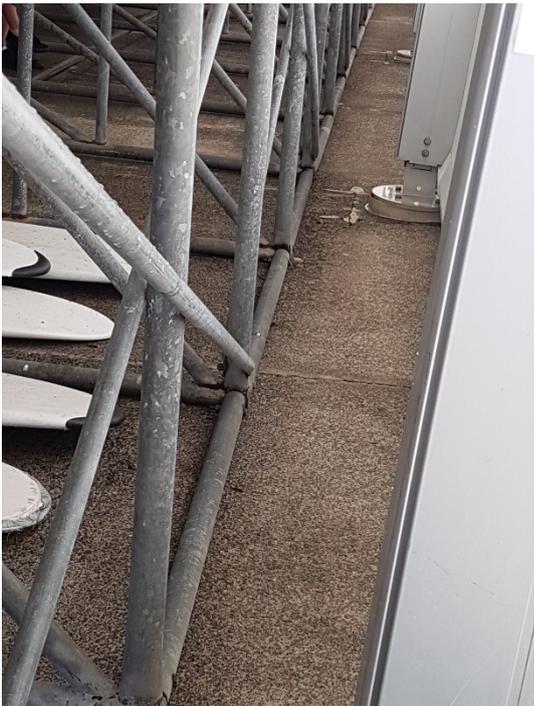
9.1.5.3	Surface corrosion at rear

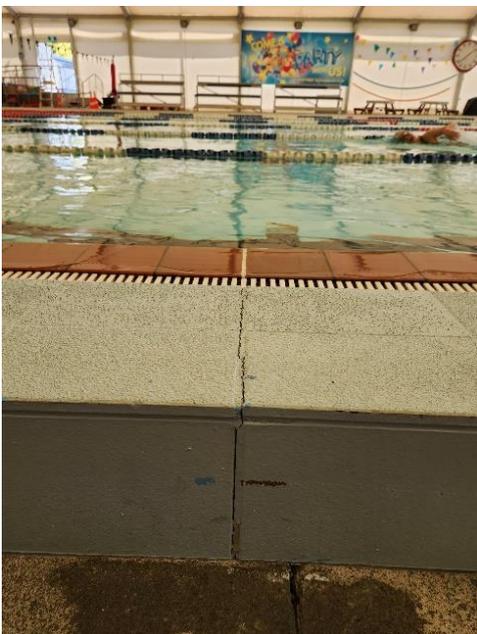
3.5.1 POOL TANK

Approximately 18 months prior to this visit a pipe running under the pool tank had severed likely due to settlement from the western (grandstand) to eastern end. Cracking along the width of the tank was observed. The pool was drained for the cracked section of tank to be cut out, and a flexible pipe was put in place before being backfilled and repaired. Cracking observed in the perimeter blocks could indicate settlement following the repair.

It is recommended that settlement is monitored along the perimeter of the pool at corners, crack locations, and in between – a total of ten points. Standard settlement monitoring pins should be installed close to the scum channel and level surveyed on a monthly basis to determine if settlement is ongoing. Survey intervals can be reviewed after 4 months.

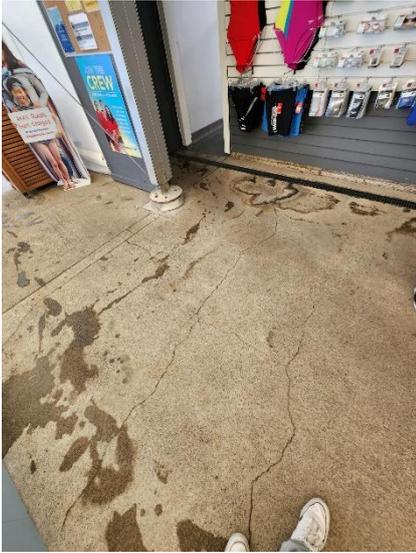
3.5.2 CONOURSE AND BLEACHERS

The slab is still significantly cracked, and reinforcement bars are still exposed in some areas. It is recommended that rust on exposed reinforcement is removed, and cracks / exposed bar are sealed with an epoxy-based product. Movement joints also remain unsealed, and we recommend that they are also resealed with a suitable flexible sealant.

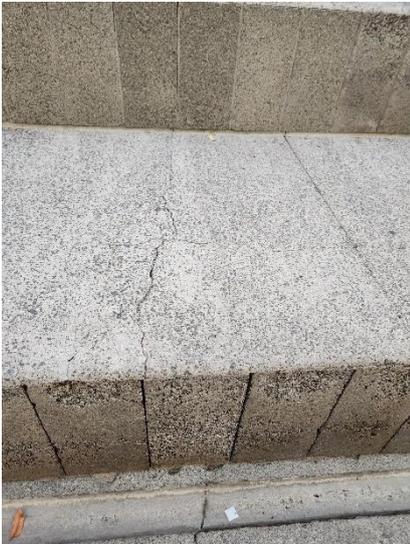
There are many gaps and crevices in the bleachers and some face shells of the blocks have broken away. It is recommended that the gaps and crevices are sealed with a suitable epoxy-based product, and the gaps in the blocks are replaced or filled with cement grout.

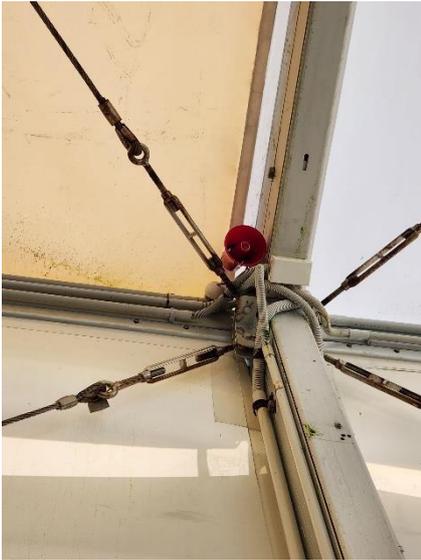
3.5.3 ROOF STRUCTURE

There is still minor surface corrosion evident to wire rope bracing cables, ferrules, thimbles, eye bolts, turnbuckles, and bolts, likely due to condensation. While not structurally significant, this is a long-term durability issue, and these items will require replacement.

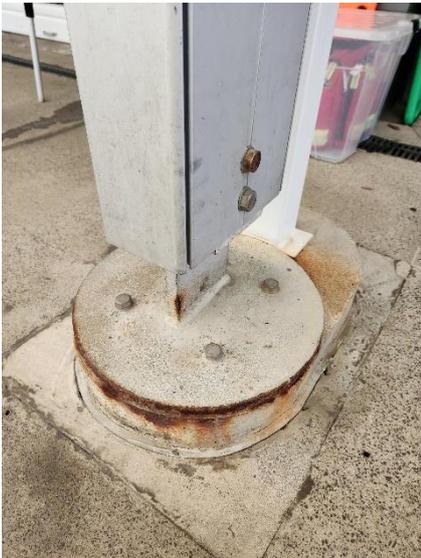
There is still minor surface corrosion evident to the roof frame baseplates likely due to water ponding. While not structurally significant, this is a long-term durability issue. It is recommended that the baseplates and bolts are cleaned, and corrosion protection reinstated.

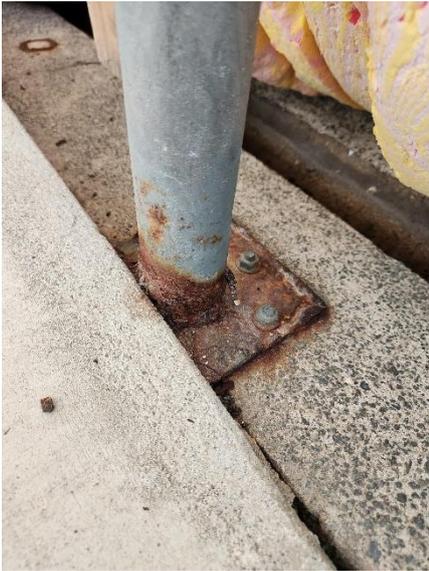
3.5.4 RAMP ACCESS

There is surface corrosion to the ramp balustrade plate fixings, tubes, and welds, most likely due to pool water running down the balustrade. It is recommended that the rusting areas are cleaned where possible, and corrosion protection reinstated.

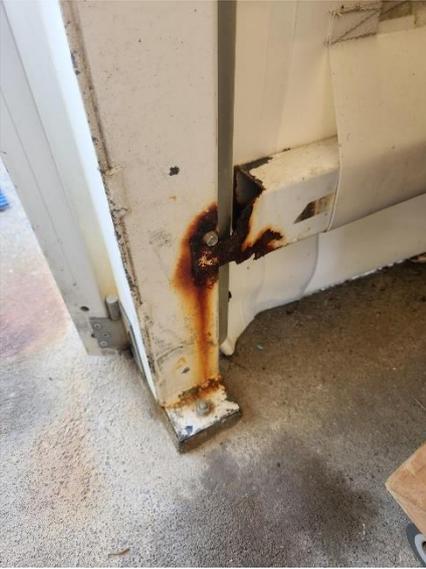
COVER BASE FIXING

A RHS section holding the wall cover adjacent to the southeast entrance (entrance closest to the balance tank) has corroded. Associated rust should be cleaned, and corrosion protection reinstated.

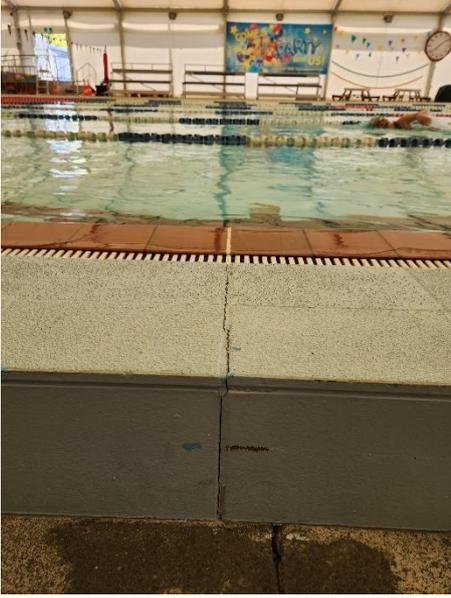
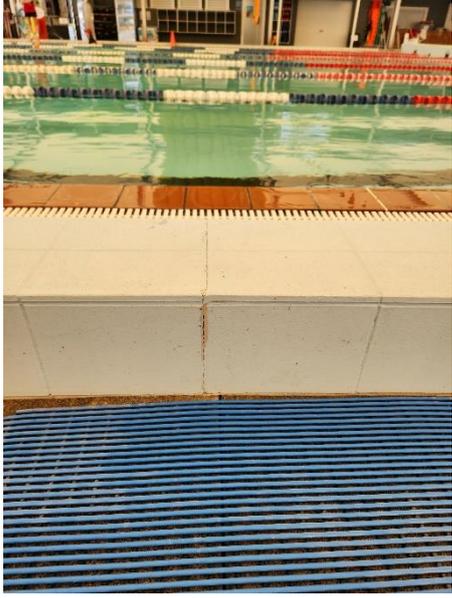
9.1.1.1 Crack Along Middle of Pool on South End		9.1.1.2 Crack Along Middle of Pool on North End

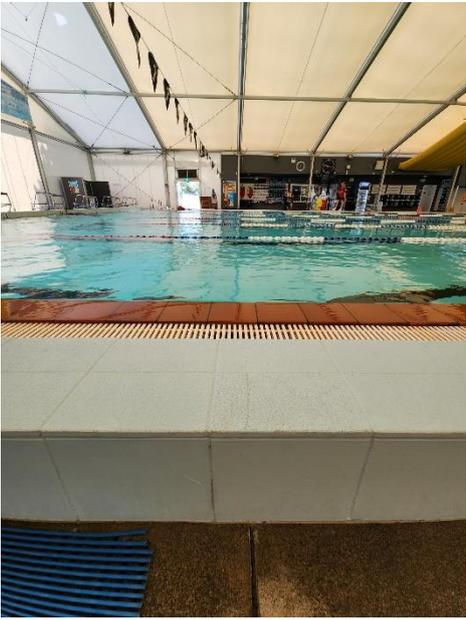
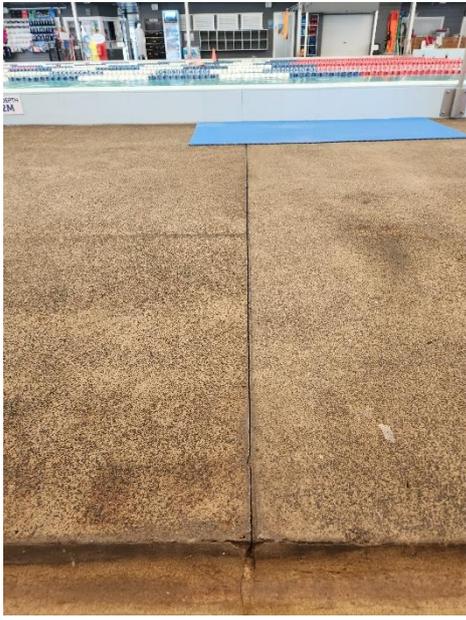
9.1.1.3 Crack between Middle and End of Pool on North End		9.1.1.4 Crack in Line with Joint on North End

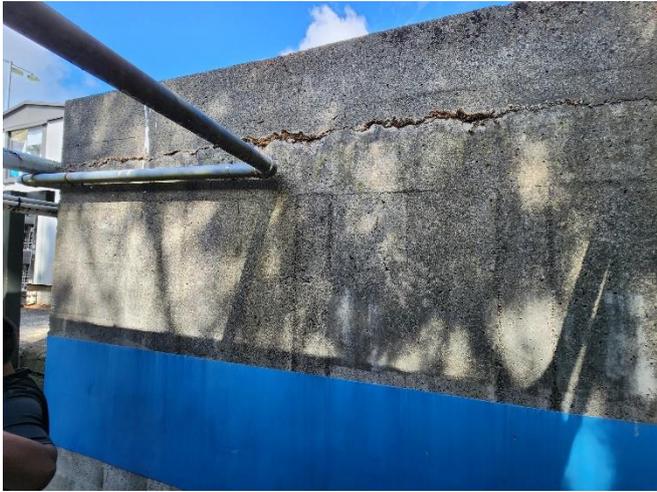
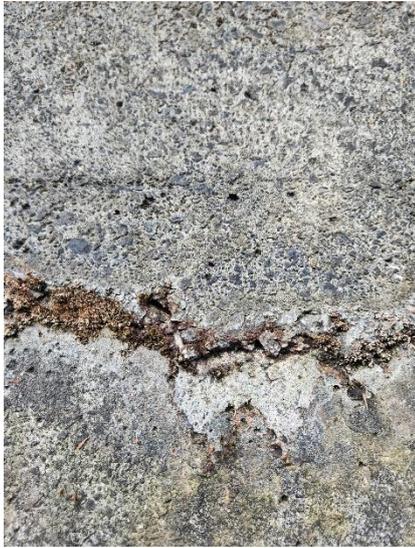
Component	Description	Findings	Recommendation	Photo	Timing	Cost
Concrete Box	The balance tank is cast-insitu concrete box.	We have not noted structural damage. The walls are discoloured, however, this has most likely been caused by corroding steel pipes leading from the pool into the balance tank. Grout repairs have been carried out on the construction joint and bay venues have verbally confirmed no water leakage or overflow has been observed following the repairs.	The balance tank should be monitored for leakage.	9.1.2.1 9.1.2.2	N/A	N/A

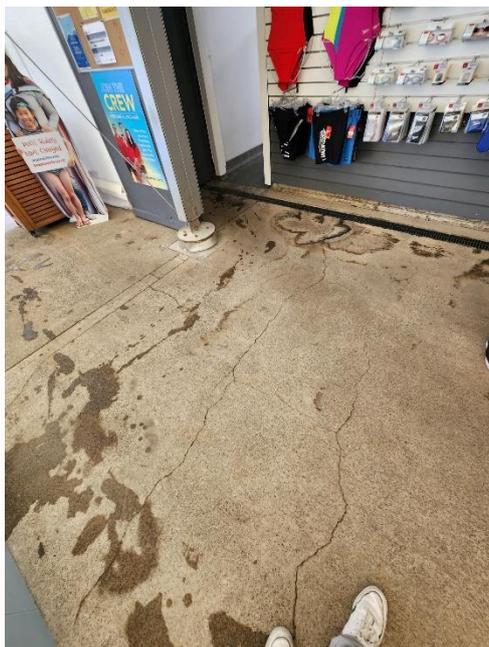
9.1.3.1 Severe Cracking

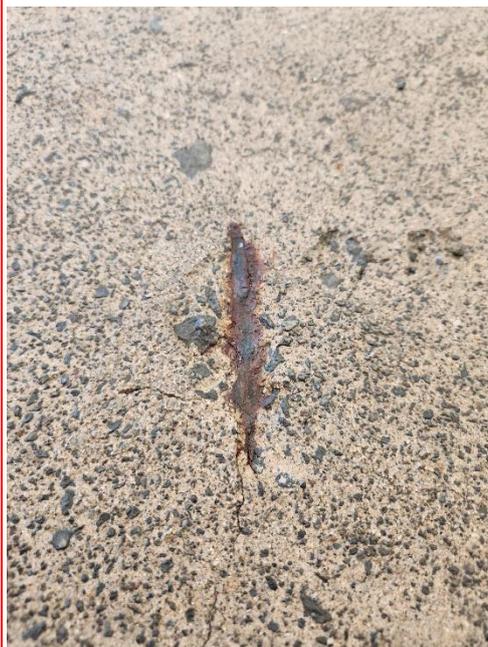
9.1.3.2 Exposed Reinforcement

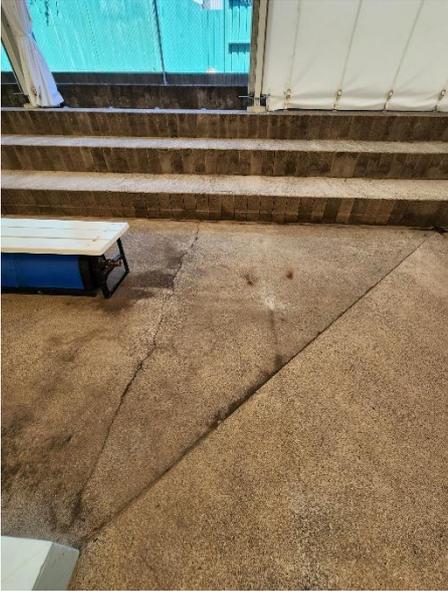
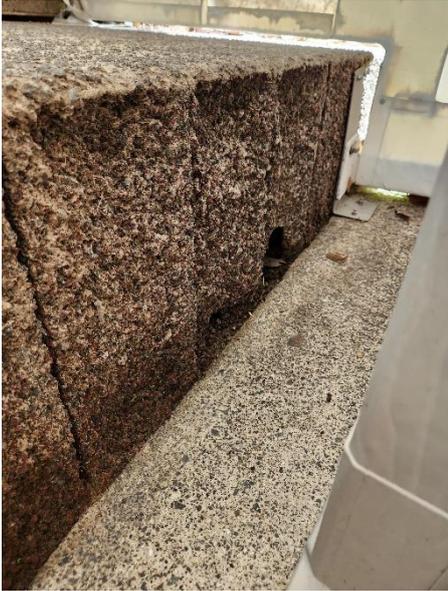
9.1.3.3	Unsealed Joints			9.1.3.4	Broken Concrete Block

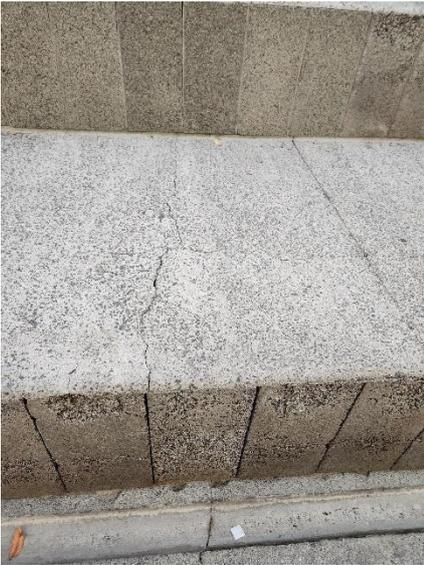
Many gaps and crevices.	Seal with suitable epoxy based product (e.g. Sikafloor264).	9.1.3.4 9.1.3.5	1 Year	\$15k to \$20k

9.1.3.5	Gaps and Crevices

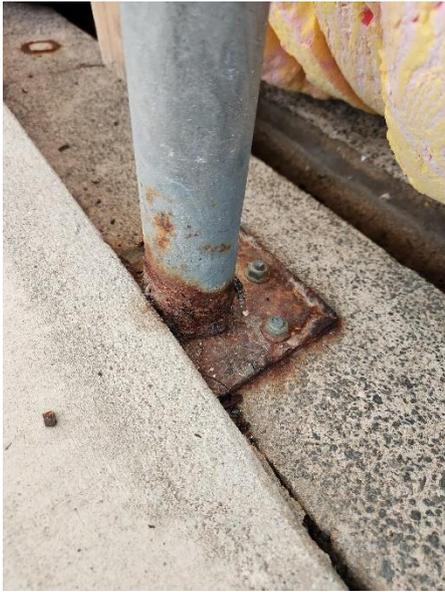
Component	Description	Findings	Recommendation	Photo	Timing	Cost
Ramp Balustrade	Galvanised steel tube with plate fixings	Corrosion to post base plates and other areas of balustrade.	Clean baseplates, tubes, and welds where possible, and reinstate corrosion protection.	9.1.5.1 9.1.5.2 9.1.5.3	1 year	\$2k if tied into other works
Ramp	In-situ concrete	Cracks along the sides of the landing internally	Injection grout crack with epoxy to fill and seal, preventing ingress of water and oxygen to arrest reinforcement corrosion.	9.1.5.4 9.1.5.5	1 year	\$3k if tied into other works

9.1.5.1 Corrosion on baseplate

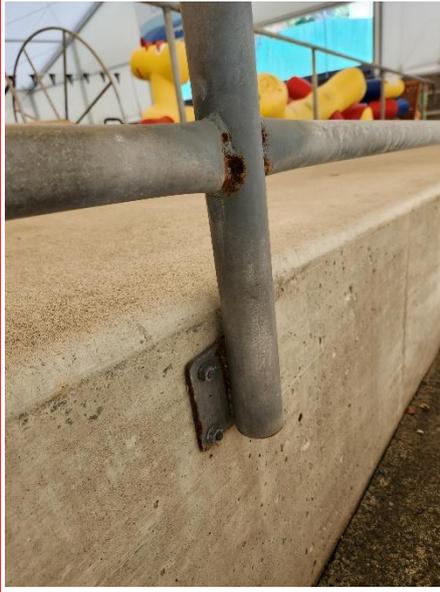
9.1.5.2 Corrosion on weld

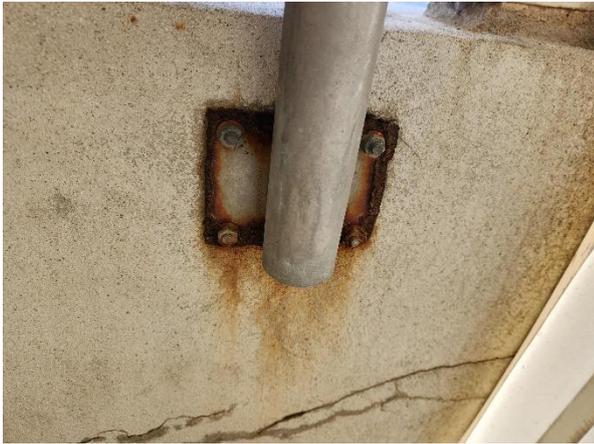
9.1.5.3 Corrosion

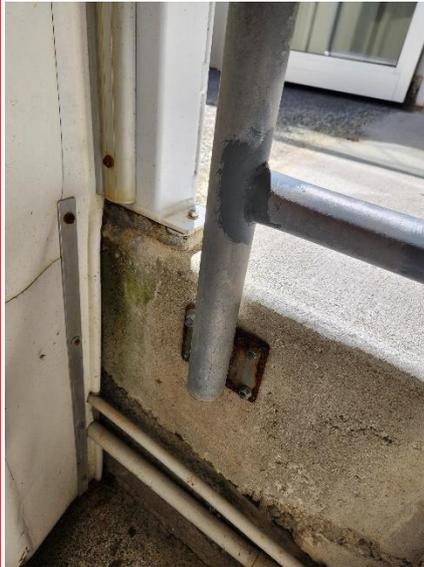
9.1.5.4 Concrete discontinuity internally

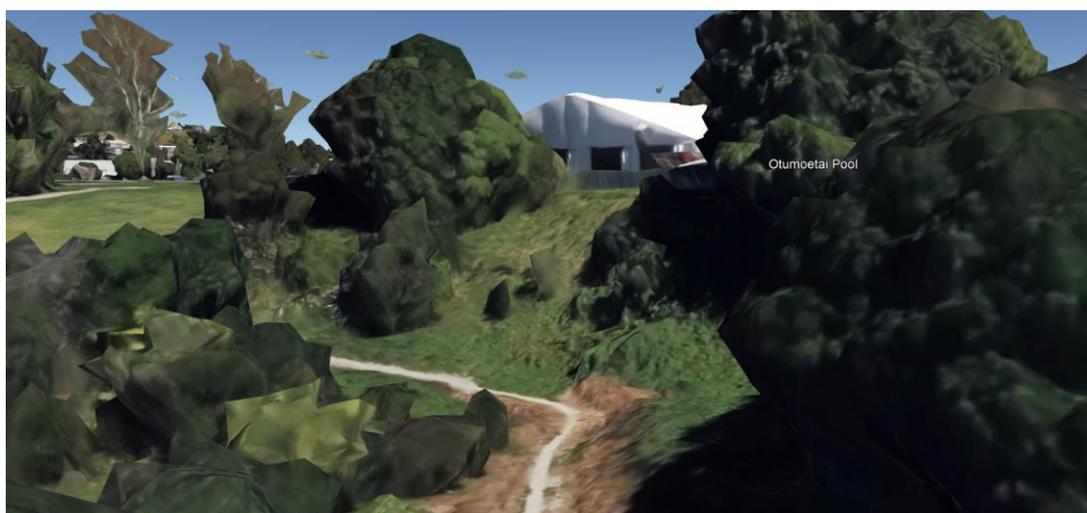
Figure 1 Google Earth view showing slope at the slope at the eastern end of Otumoetai Pool

The pool is located close to a slope on the eastern side of the building. The observed pool damage may be related to this slope and/or ground effects under the pool. Geotechnical investigations and assessment would be required to understand and advise further on this.
