Ōtūmoetai Pool - Information Pack

Asset Condition Assessment

OTUMOETAI POOLS CONDITION ASSESSMENT

21 MARCH 2024

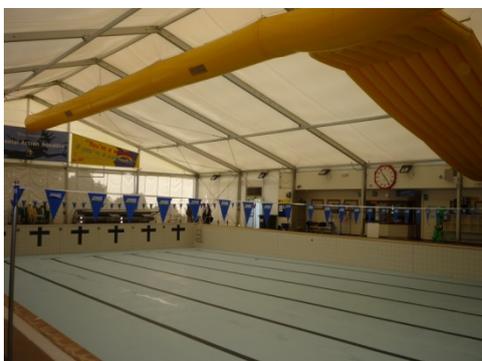
4.4.1 Pool Tank

The Pool Tank comprises a cast-insitu concrete floor with what appears to be precast concrete walls. Behind the side walls a concrete scum channel forms the transmission to the concourse. The floor is painted and the walls are tiled. The pool tank accommodates a 7 lanes pool and a non-swimmer pool. The areas are divided by a concrete bulkhead.

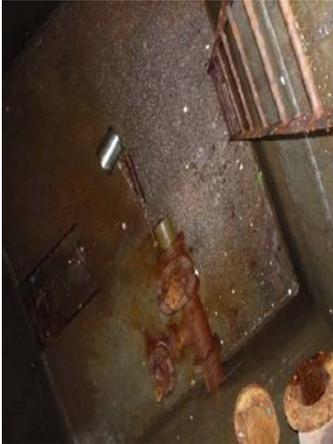
4.4.2 Balance Tank

The Balance Tank is located outside the Pool Shade Structure and only partially embedded into soil. The whole structure is cast-in-situ concrete. A round steel lid provides access. A few air holes are built into the concrete top.

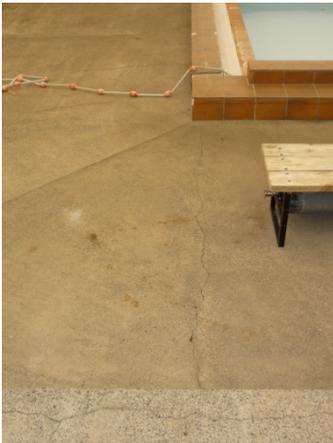
4.4.3 Concourse and Bleachers

A concrete slab forms the pool surrounding concourse. The slab is jointed at regular intervals.

Bleachers are located at the end where the learners pool is. The Bleachers are constructed of concrete block walls and cast-in-situ concrete slabs.

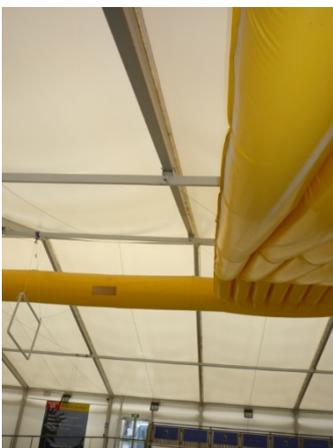
4.4.4 Roof Structure

The pool shade structure has been supplied by “Karl Hocker Stahlbau GmbH, Germany” and has been constructed about 2002. The structure comprises aluminium portal frames, stainless steel bracing cables and mild steel components like base plates and some connection elements

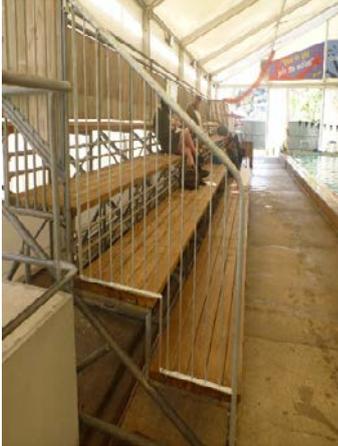
4.4.5 Pool Grandstand

The pool grandstand is located along the northern side of the lane pool, providing seating for swimmers and spectators. The grandstand consists of timber seating spanning between triangulated frames fabricated from galvanised steel tubes.

The frame connections at the front of the grandstand all show signs of corrosion, varying from relatively minor to full through thickness failure. The corrosion is limited to the joint locations where original corrosion protection has been affected by welding and either not or insufficiently reinstated. The corrosion is due to the aggressive pool water being splashed onto the frames from the concourse slab. This is a short term durability issue.

Other frame connections also show signs of corrosion, though not as significant as the front as they are elevated and more distant from the pool and less likely to be splashed. The corrosion is likely to be due to water dripping from swimmers on the grandstand and condensation.

It is recommended that the grandstand structure be repaired by removing surface corrosion and reinstating corrosion protection to joints as required. The joints at the front of the frames may require partial replacement where corrosion and loss of material thickness is significant. A higher specification corrosion protection should be considered here (two component epoxy paint) as well as lifting the grandstand slightly to prevent immersion in ponding water.

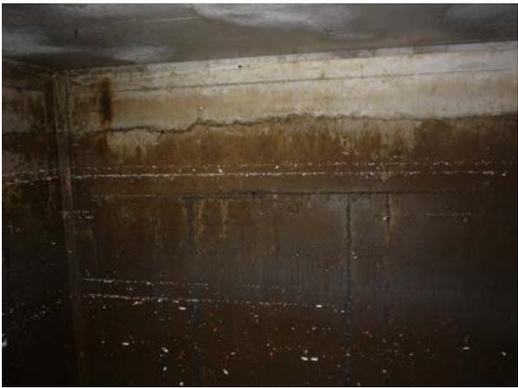
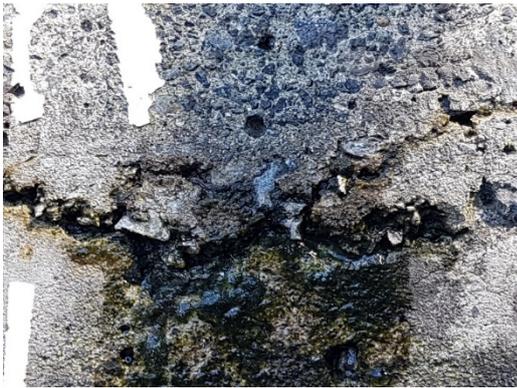
Component	Description	Findings	Recommendation	Photo	Timing	Cost
Concrete Box	The balance tank is cast-insitu concrete box.	We have not noted structural damage. The walls are discoloured, however, this has most likely been caused by corroding steel pipes leading from the pool into the balance tank. There are signs of water leakage through the original wall to roof construction joint though no signs of reinforcement corrosion are evident as yet. The pool operator reported that the capacity of the tank is insufficient at peak times.	The construction joint should be injection grouted with epoxy to fill and seal the construction joint, preventing further ingress of water and oxygen to arrest reinforcement corrosion. BVL may decide to act on the observed under-capacity and replace or extent the tank.	9.1.2.1 9.1.2.2	1 year	\$2k to \$2.5k

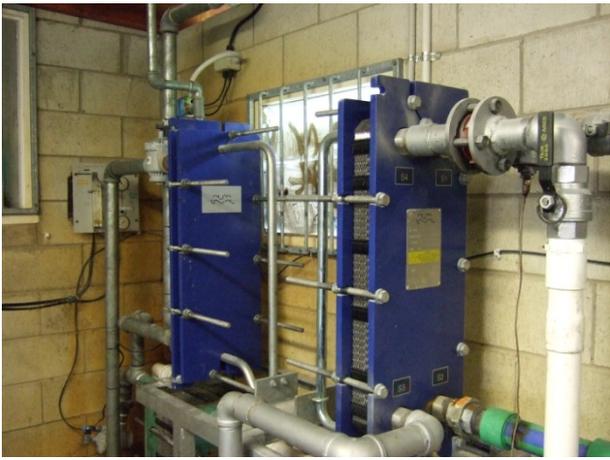
9.1.6.1 Pool Water Heat Exchanger

Component	Description	Findings	Recommendation	Photo	Timing	Cost
Pool water circulation pump	New pump installed	OK	none		Annual service	\$500
Pool water heat exchanger	Alfa Laval	Good working condition	Inspect and clean	9.1.6.1	Annual service	\$1k
Pipes and manholes	Pipes to pools and balance tanks	Water over flowing through manholes	Inspect pipes for blockages, seal manhole lid		Annual service	\$500
Balance tank levels, floats.	Floats and levels		Inspect condition and operation of floats and levels		N/A	\$3k
Balance tank	Balance tank appears to be too small		Enlarge balance tank if required		N/A	\$50k

Recommendations: clean the heat exchanger plates on regular bases.

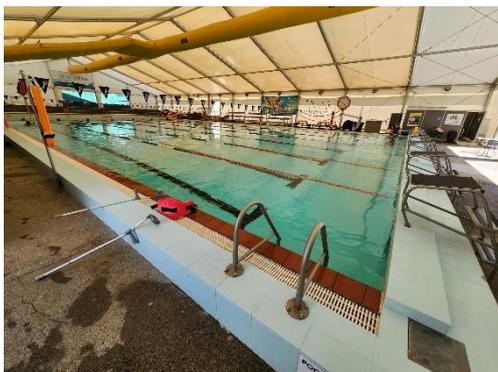
3.4.1 POOL TANK

The pool tank comprises a cast-insitu concrete floor with what appears to be precast concrete walls. Behind the side walls a concrete scum channel forms the transmission to the concourse. The floor is painted, and the walls are tiled. The pool tank accommodates a 7 lanes pool and a non-swimmer pool. The areas are divided by a concrete bulkhead.

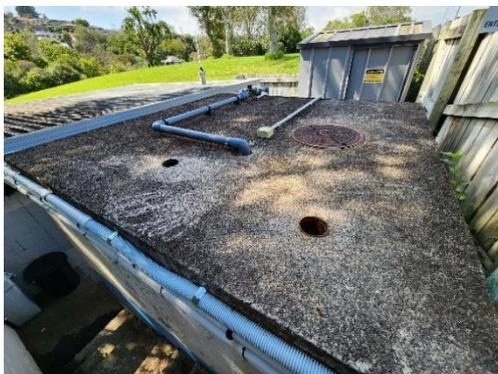
3.4.2 BALANCE TANK

The balance tank is located outside the Pool Shade Structure and partially embedded into soil. The whole structure is cast-insitu concrete. A round steel lid provides access. A few air holes are built into the concrete top.

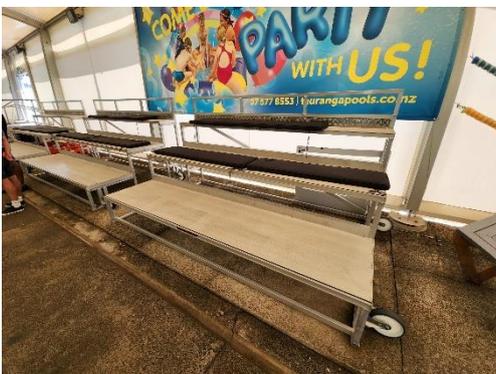
3.4.5 POOL GRANDSTAND

The pool grandstand is located along the northern side of the lane pool, providing seating for swimmers and spectators. Following from the previous report recommendations, the old grandstand was replaced. The new grandstand consists of steel seating spanning between rectangular frames fabricated from galvanised rectangular hollow sections.

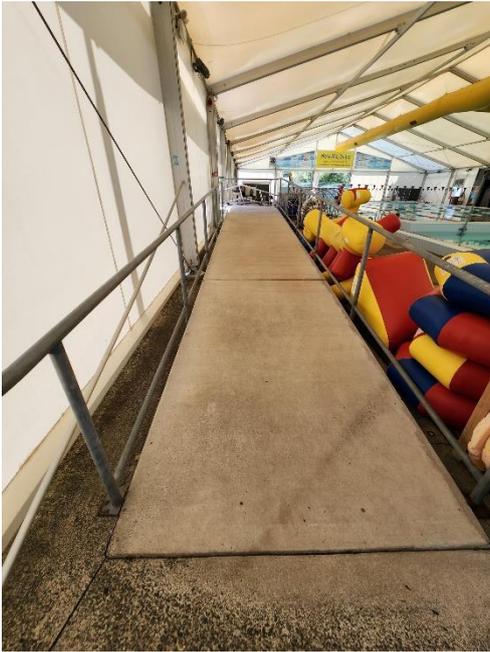
3.4.6 RAMP ACCESS

The ramp access comprises a cast-in-situ concrete landing and ramp with a steel balustrade. The ramp accommodates disabled access at the northern end of the pool.

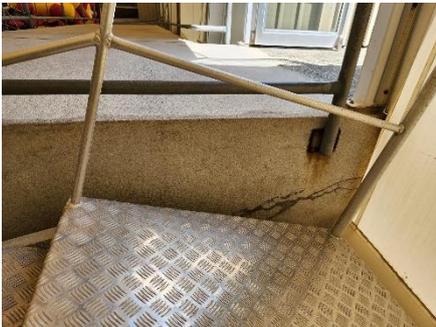
There is diagonal tension cracking along the landing of the ramp. It is recommended that the cracks are injection grouted with a suitable epoxy-based product to fill and seal, preventing ingress of water and oxygen to arrest reinforcement corrosion.

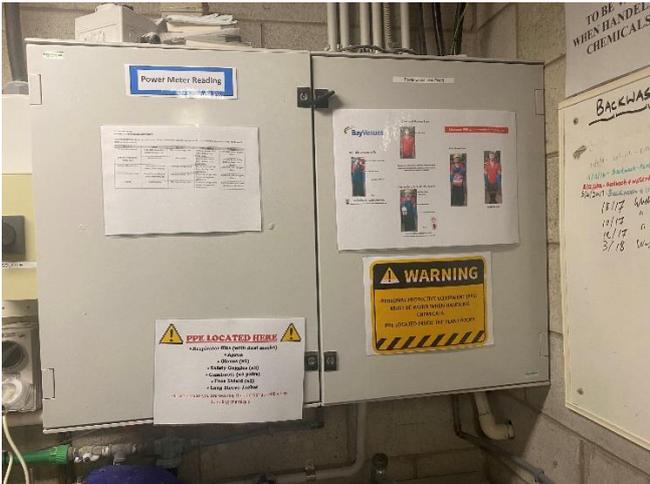
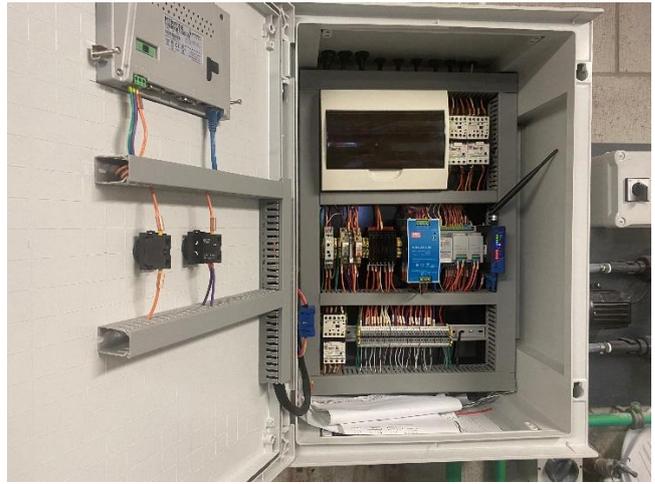
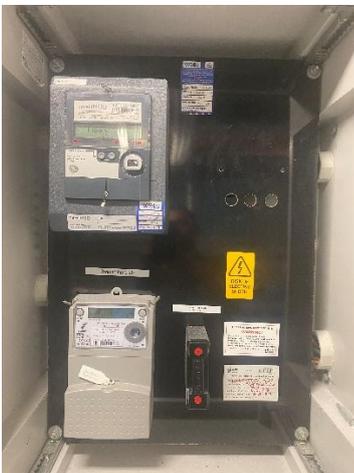
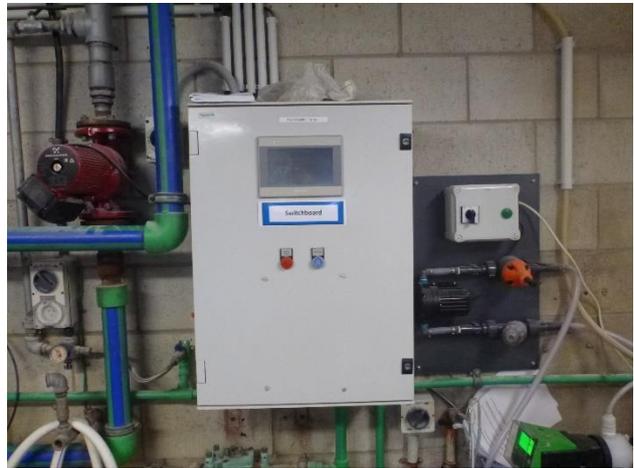
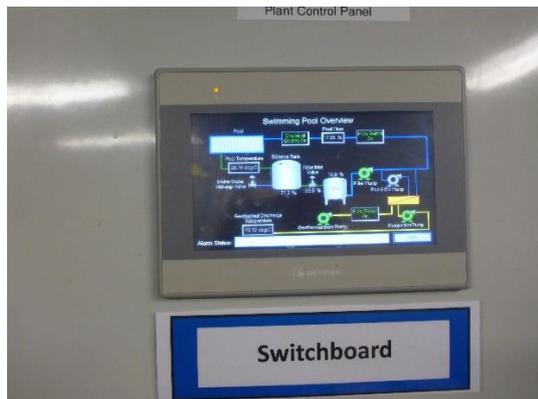
The main switchboard (bottom two left photos) was replaced in 2022. The switchboard is off a quality finish and quality installation.

The control panel (bottom three right photos) was replaced in 2022. There is an HMI (Human machine interface) panel allowing the client and contractors to view the system function/temperature at every necessary point.

Majority of the electrical equipment (Wiring, switchboards, switches, and the like) had been replaced as part of the upgrade works in 2022. There are clear labels and instructions posted on equipment allowing for safe and easy operation of plants.

The expected life of the upgraded electrical equipment above is 20-30yrs. That is if the electrical equipment is properly closed off after inspections, as chlorine deposits are evident on top of cabinets.

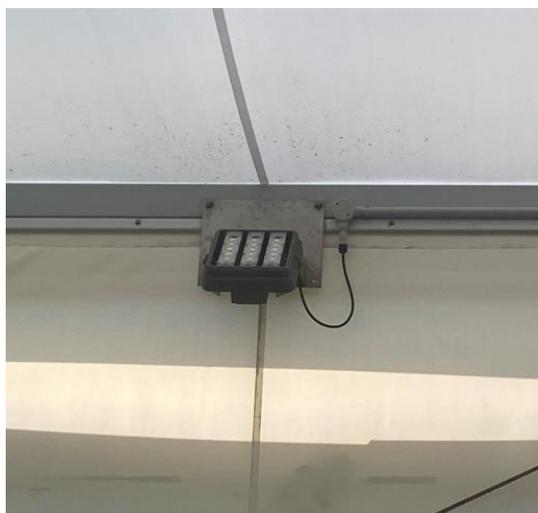
All pool general lighting is LED type. There are locations where the lighting are installed too close to the canvas roof panels. It is not a good design practise to have light fittings too close to such a surface.

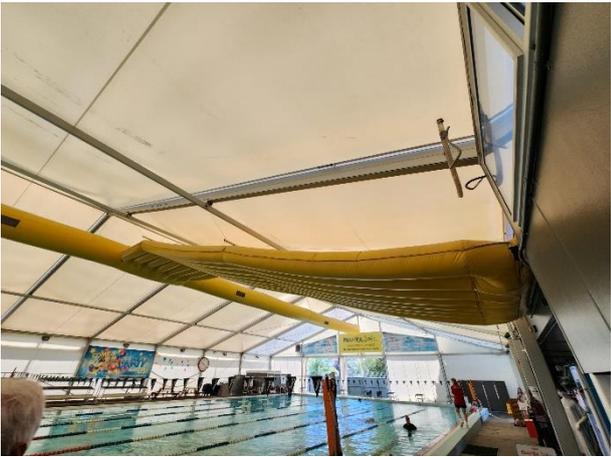
Component	Description	Findings	Recommendation	Photo	Timing	Cost
	Base fixings	One fixing into portal column has corroded	Associated rust should be cleaned and corrosion protection reinstated.	9.1.4.2	1 Year	\$1k if tied into other works
Portal Frames	The portal frames are made of aluminium at regular intervals.	The frames appear in very good condition, no visible signs of corrosion.	Retain, wash regularly with clear water.	9.1.4.3	N/A	N/A
Bracing	The cables and fittings providing bracing are stainless steel.	Surface rust.	Wash regularly with clear water. Will require replacement in medium term.	9.1.4.4	10 years	\$30k to \$40k
	Some steel elements have been used for connection brackets.	The painted protection system appears to break down at some areas.	Reinstate. Will require replacement in medium term where reinstatement not possible.	9.1.4.5	1 Year	\$20k to \$30k
Base Plates	The base plates and connection cleats to the aluminium frames are made of "black" steel.	The protection system appears to break down at some areas with minor surface corrosion evident.	Reinstate corrosion protection system. Seal crevice between steel and concrete.	9.1.4.6	1 Year	\$30k to \$40k

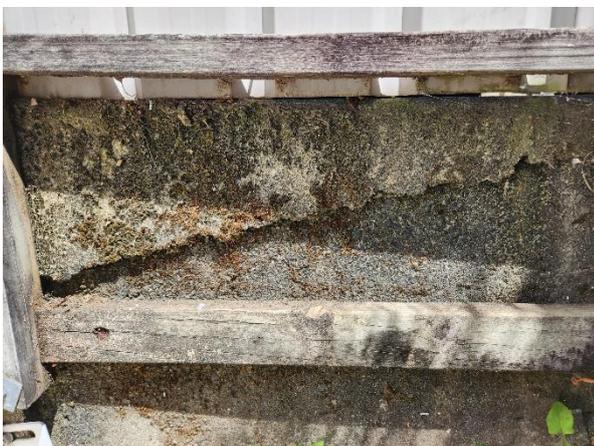
9.1.5.5 Concrete discontinuity externally

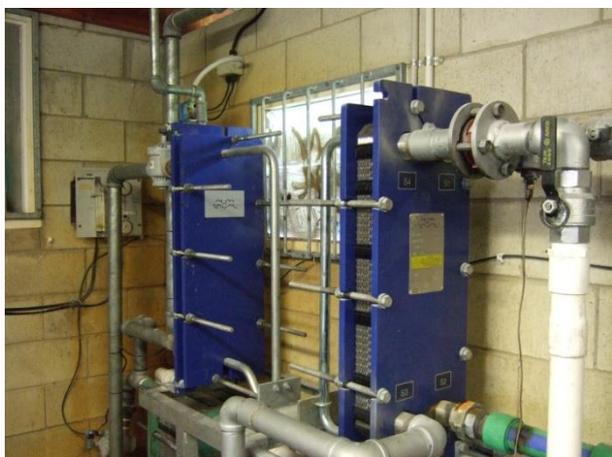
9.1.6.1 Pool Water Heat Exchanger

Component	Description	Findings	Recommendation	Photo	Timing	Cost
Pool water circulation pump	New pump installed	OK	none		Annual service	\$500
Pool water heat exchanger	Alfa Laval	Good working condition	Inspect and clean	9.1.6.1	Annual service	\$1k
Balance tank levels, floats.	Floats and levels		Inspect condition and operation of floats and levels		N/A	\$3k
